THE ACTIVITIES OF DISASTER - AFFECTED HOUSE IDENTIFICATION IN TANGERANG DISTRICT

Abstract

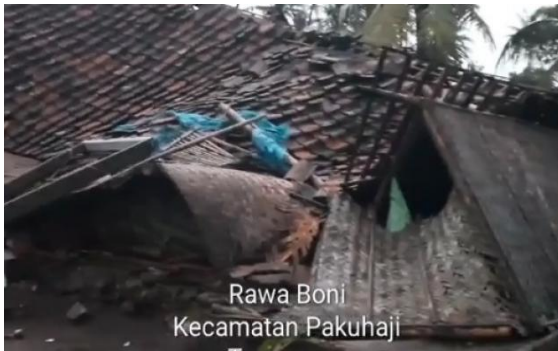
Figure 2. Houses in Pakuhaji Sub-district were damaged by a tornado on Monday (1/2/2021)

As shown in Figures 2 and 3, the tornado that occurred on February 1st, 2021, caused light to severe damage to at least 86 houses in three villages in the Laksana, Rawaboni, and Bonisari villages Pakuhaji sub-district.

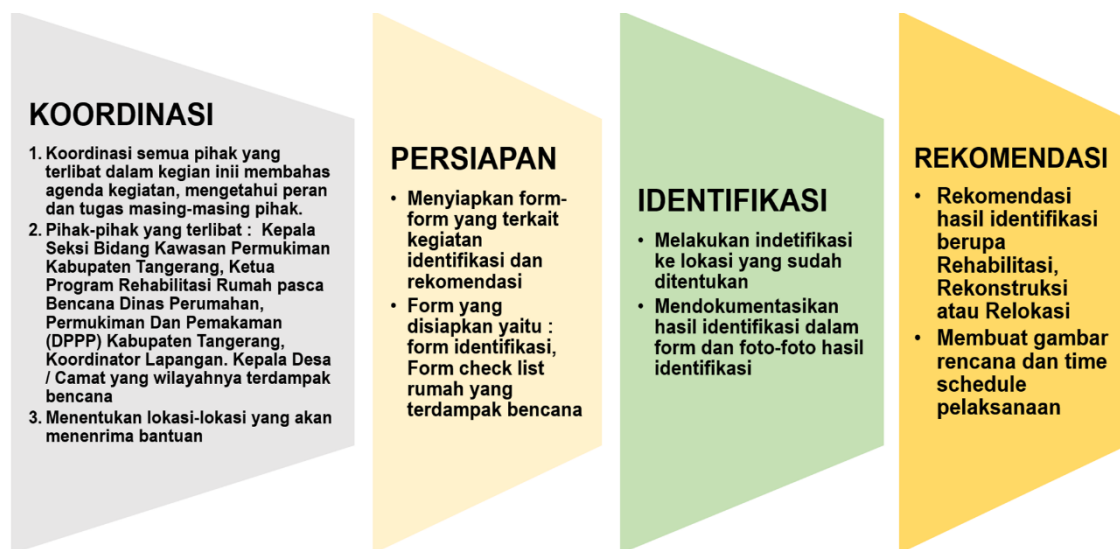
Figure 5. Stages of Activities

The activity stages include coordination activities, preparation activities, identification activities, and recommendations which are described in Figure 5 as follows:

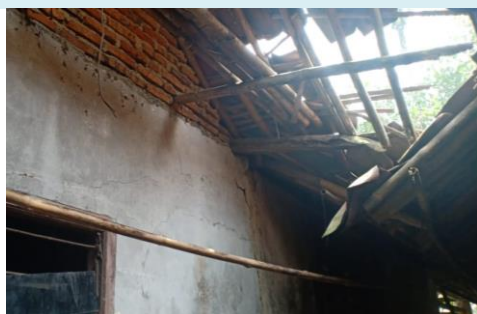
Figure 7. House of Mrs. Kartini

Roof construction is made of rotting bamboo. It has collapsed when a big wind hits it.

No	Homeowner Name	districts	Damage Rate	Recommendation
1.	Mrs. Kartini	Jambe	ALMOST FALLEN	Reconstruction
2.	Mrs. Bona	Jambe	WEIGHT BROKEN	Relocation
3.	Mrs. Wati	Jambe	WEIGHT BROKEN	Relocation
4.	Mr. Jahim	Rajeg	WEIGHT BROKEN	Reconstruction
5.	Mr. Ojah	Tigaraksa	ALMOST FALLEN	Reconstruction
6.	Mr. Hasanudin	Pakuhaji	WEIGHT BROKEN	Reconstruction

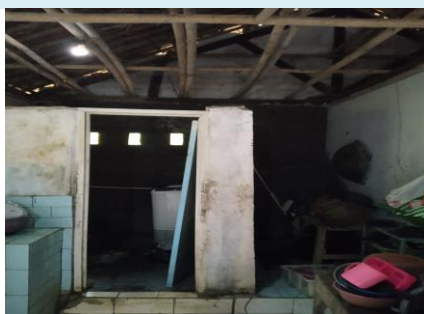
The condition of the room in the house is damaged due to the fragile roof structure.

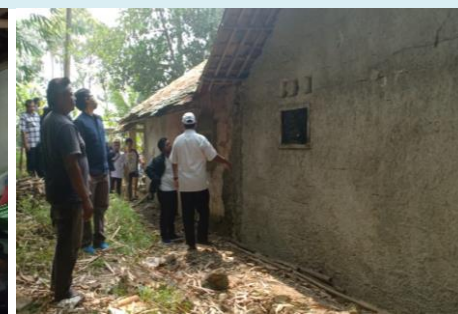
No column reinforcement, so it is very prone to collapse.

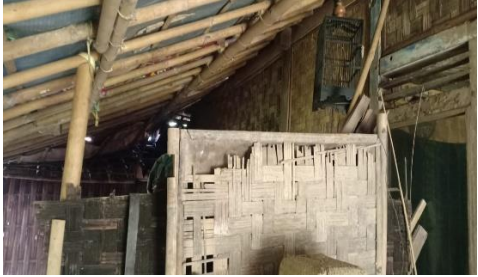
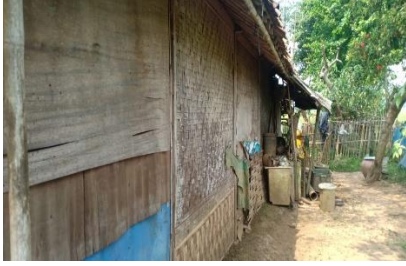
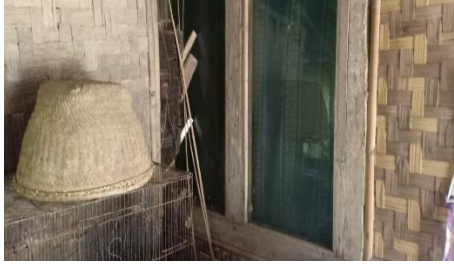
Figure 8. House of Mrs Bonai

The roof construction was made from rotting bamboo. It has collapsed when hit by strong winds.	The wall condition is due to frequent flooding every time a flood comes.	No column reinforcement, so it is very prone to collapse.

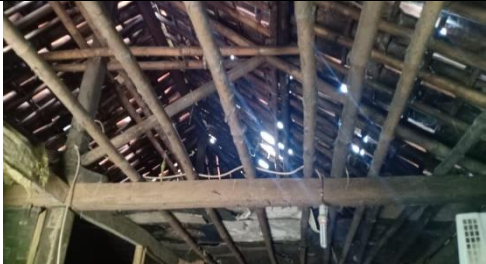
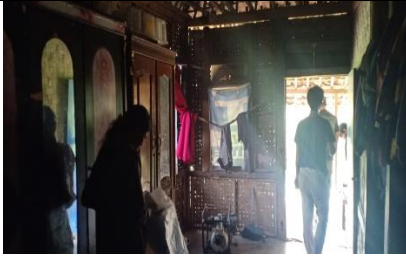
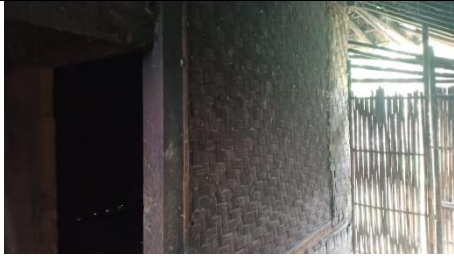
Figure 9. House of Mrs Wati

Roof construction is made from rotting bamboo. It has collapsed when hit by a big wind.	The wall condition is due to frequent flooding every time a flood comes.	No column reinforcement, so it is very prone to collapse

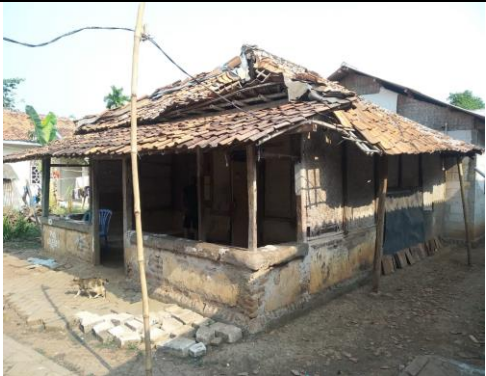
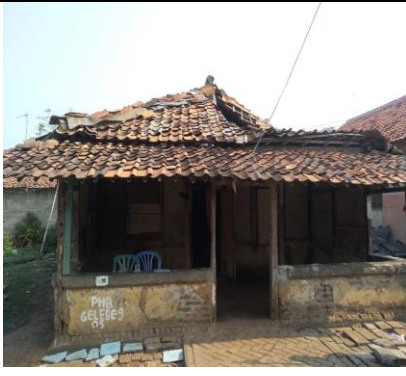
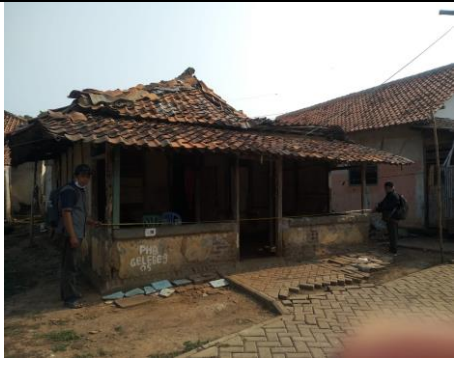
Figure 10. House of Mr. Jahim

Column structures, ring barks, and roofs that are not functional are very susceptible to collapse. For the lower part of the structure, the condition of the rolag bricks is still good and can be used. A tornado caused this damage.

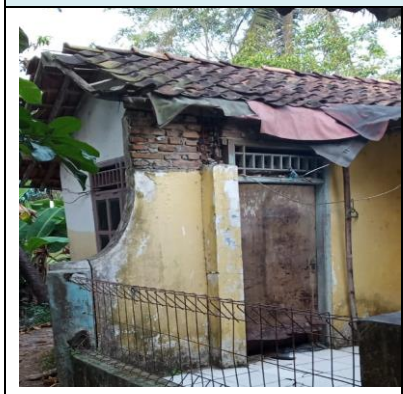
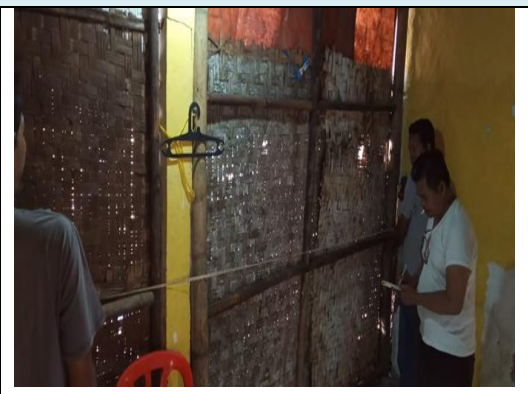
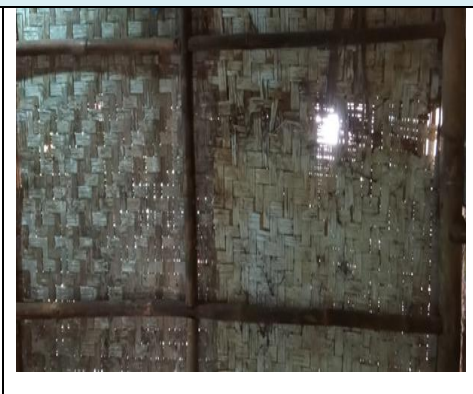
Figure 11. House of Mr. Ojah

<p>Roof construction from rotting bamboo had collapsed when a hurricane hit it.</p>	<p>The room condition in the house is damaged due to the fragile roof structure.</p>	<p>There is no column reinforcement, so it is very prone to collapse.</p>

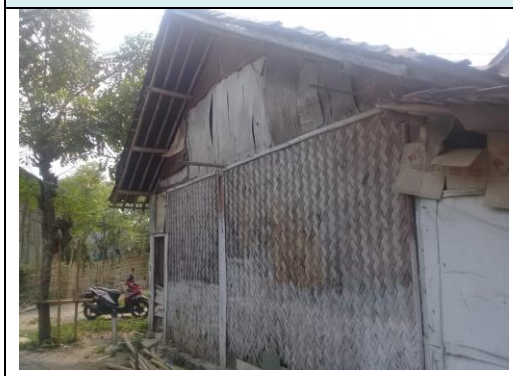
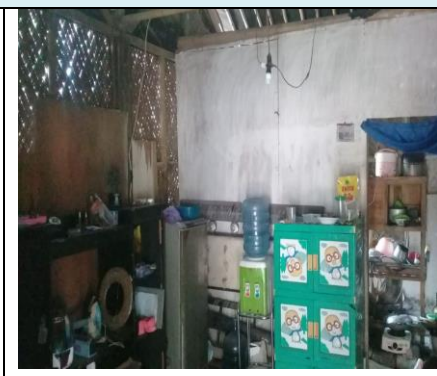
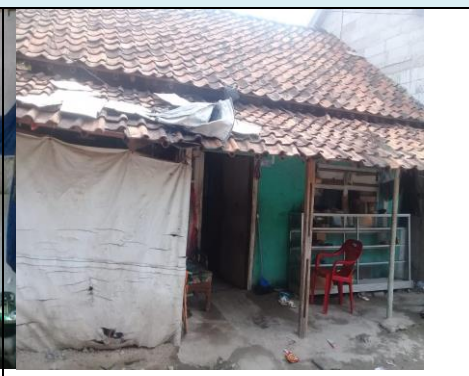
Figure 12. House of Mr. Hasanudin

<p>Roof construction from rotting bamboo had collapsed when a hurricane hit it.</p>	<p>The room condition in the house is damaged due to the fragile roof structure.</p>	<p>There is no column reinforcement, so it is very prone to collapse.</p>
